TO: City Council  
DATE: May 9, 2024  
ITEM #: 12.B  
SUBJECT: Consider approval of a contract for repairs to the Marshall Police Department building. (Support Services Director)

Investigative Services to Identify Moisture Intrusion Issues at the Marshall Police Station

February 13, 2024

KSA was engaged to provide Investigative Services for the City of Marshall, Texas at the Marshall Police Department. The project is located at 2101 E. End Boulevard North in Marshall, TX 75670. Architects performed this investigation of the existing building to provide an evaluation of existing conditions and recommended corrective measures. This document is structured according to a four-section layout as described below.

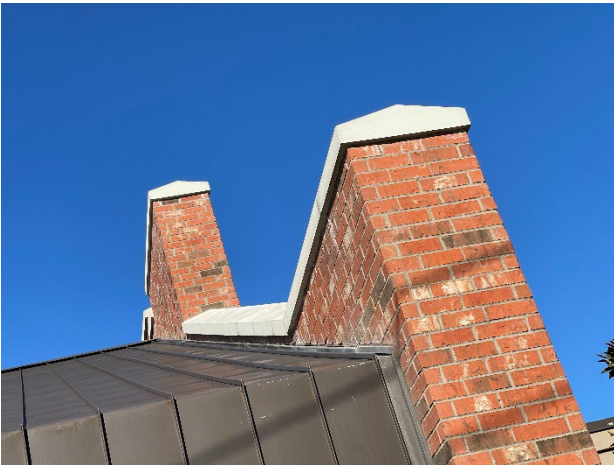
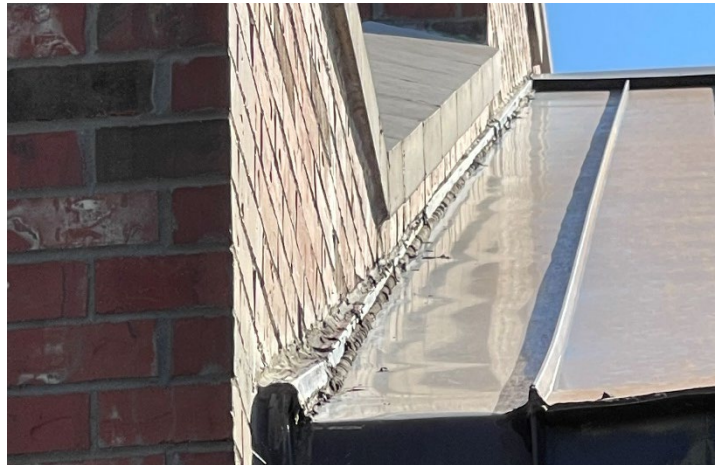
At the backside of the entry gable, the top metal trim piece is not fully encased in the masonry with grout. On the other side sealant has been excessively used in an attempt to minimize gaps in the trim and masonry veneer.

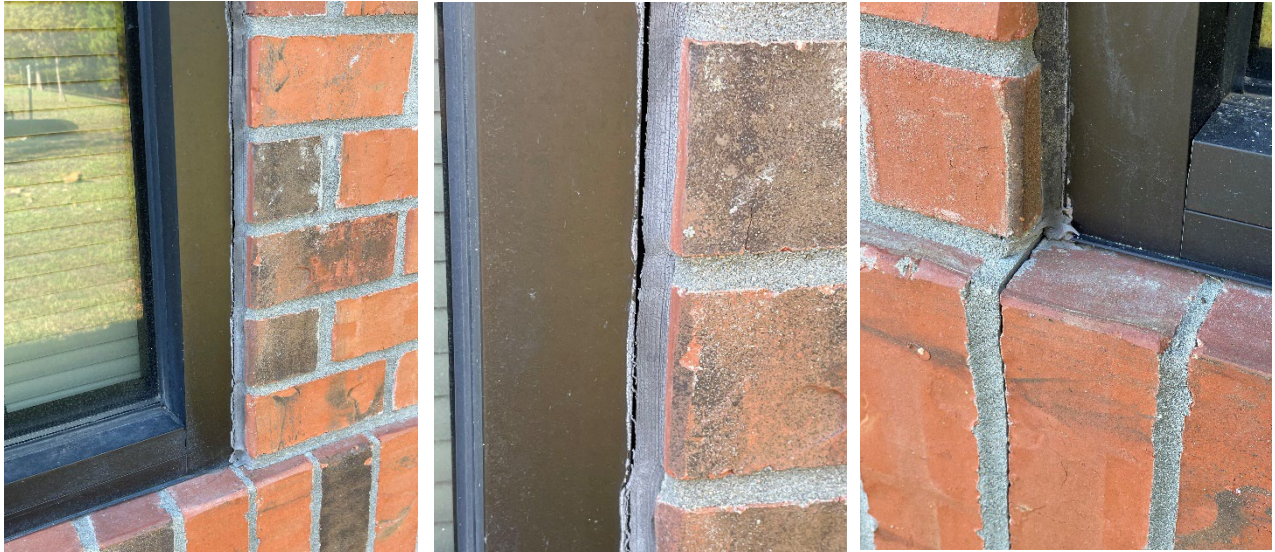
Exterior window openings have sealant failure at most locations. Windows are also experiencing some movement due to original installation methods.

Varying gap thicknesses are noted around all windows from the window movement and sealant failure. Masonry movement and cracking is noted as well. The sill is a king size masonry unit installed as a soldier course. The soldier units are cantilevered vertically with little or no support, and they have begun to move through thermal expansion.

It is recommended that all existing windows be removed and replaced. During this corrective work, all damaged gypsum board, wood sills, and paint finish should be removed and replaced. In conjunction with work, windows to be securely anchored and sized appropriately for masonry rough opening. New flashing to be installed while windows are installed. New windows should be storefront framing system internal weeps utilizing double pane, low e glazing, and insulated units. Opinion of cost associated with this work is roughly **\$125,000.00**.

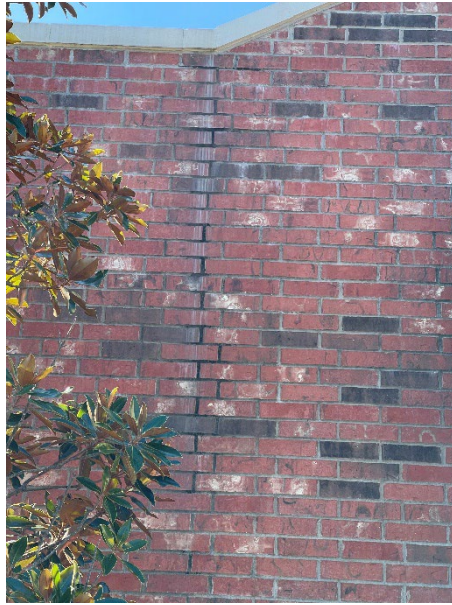
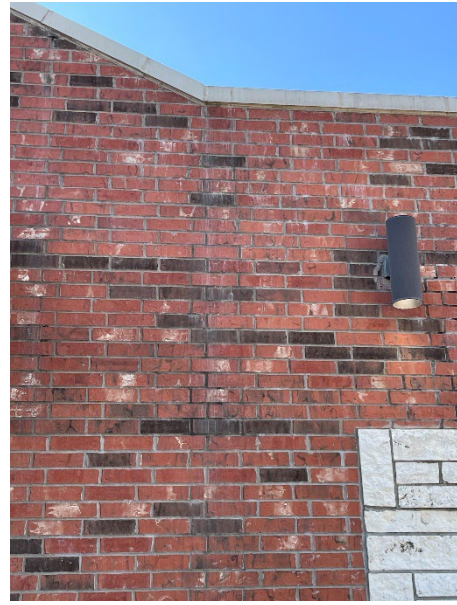
Another issue associated with the cast stone parapet cap is the sloped angle transitions at the gable features. Due to the slope of the cast stone unit, visible signs are present on the masonry veneer that water is penetrating through the unit and down the face of the exterior masonry. The white powdery substance presence on the masonry is indication of efflorescence. Efflorescence is caused by water-soluble salts in or on the subject material. In addition, moisture is present to make the salt become a soluble solution. As suspected previously, the cast stone material is porous in nature and due to insufficient flashing, water is present in the wall and the masonry and as the salts move to the masonry veneer surface, the moisture evaporates. This in turn makes the salts crystallize, which results in the apparent efflorescence.

It is recommended that due to the porous nature of the cast stone parapet cap and the insufficient flashing where the metal roof meets the back of the parapet, that these materials be completely covered in prefinished break metal to prevent water intrusion through these materials. The new metal can include metal drip edges as it covered the cast stone cap and then be installed in pieces to appropriately cover and see these elements to effectively stop the water intrusion. This will need to occur around the perimeter of the building at all locations of the gable features, where cast stone parapet caps are installed, and at the intersection of the back of the parapet and the metal roof meets. Opinion of cost associated with this work is roughly **\$75,000.00**.

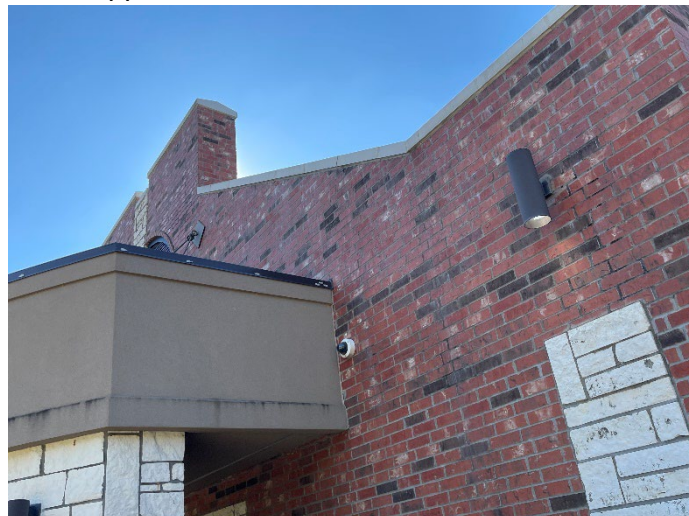
It should be noted that the white faux stone material used at the entry columns and the accents at the gable features is corbeled out from the face of the masonry veneer. This protrusion from the veneer is not protected at the head joint that runs horizontal to the face of the masonry veneer. Due to the presence

of two dissimilar materials, thru wall flashing is recommended to be provided at this location. This proception and insufficient flashing at the head of the joint is allowing water to penetration the veneer and enter the wall cavity.

It is recommended that head flashing be retroactively installed at all faux stone locations. Based on the weathering of the units and the growth of algae, water is penetrating these units from above and through the surface. Sealing as recommending above will help protect the surface; however, flashing is required to keep moisture from entering the top of the units. Opinion of cost associated with this work is roughly **\$13,500.00**.

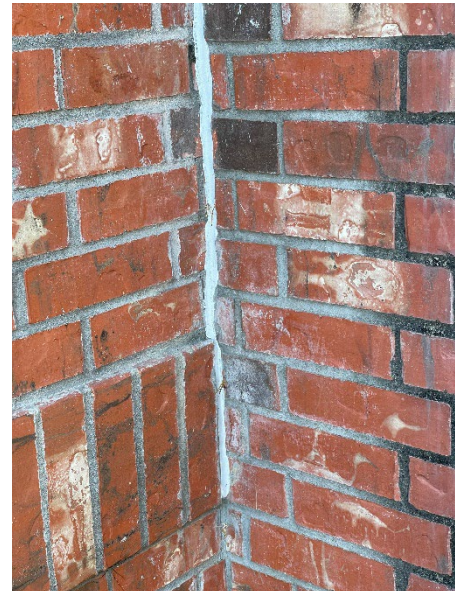
In the northwest corner it was noted that sealant has been applied to the inside corner joint of the masonry veneer and the double wythe masonry wall at this location. There are limited details that indicated the proposed construction at these locations around the perimeter of the building. However, based on visual observations, it appears that a drainage plane is not provided. As such, these locations indicate signs of water intrusion and some movement at the masonry joints. Mortar joints are not consistent and at the inside corner the joints do not align throughout.

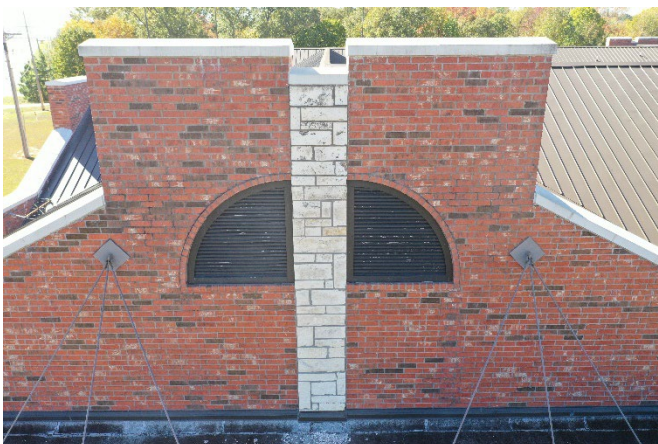
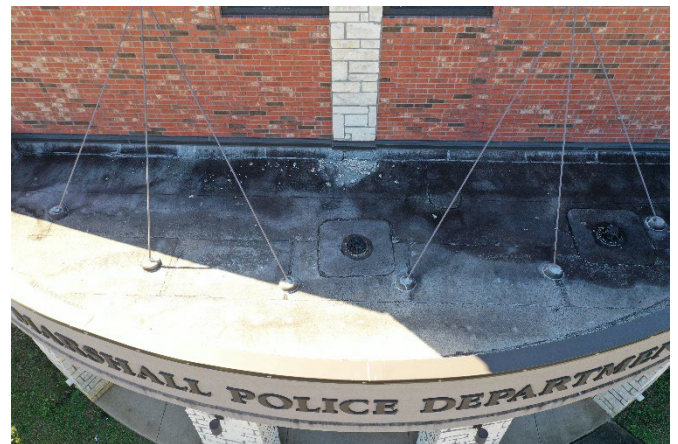
Also noted at the gable features is insufficient thru wall flashing at the gable vents. No flashing is apparent in the field or in the construction documents. In addition, the louvers appear to be of wood construction and do not provide protection from wind driven rain. This is providing another avenue for wind

The existing wooden louvers are not flashed appropriately, and the wood finish and overall condition of the louvers are deteriorating. It is recommended to help limit water intrusion through the louvers that they be removed and replaced and for new flashing to be installed during installation. Opinion of cost associated with this work is roughly **\$12,500.00**.

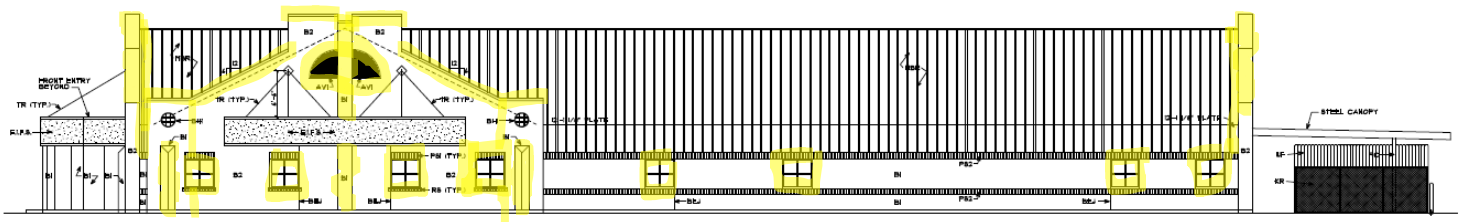
## West Elevation

The review of the West Building Elevation provided similar findings as that of the North Elevation. Note the yellow highlighted problem areas observed on this elevation. Summary of problematic areas are: cast stone cap stone at parapet walls, back side of parapet flashing issues, limited to no flashing below the cap stone, degraded sealant around perimeter of window openings, limited flashing at windows (around total perimeter), flashing at soldier course below windows and limited structural support, efflorescence at locations below the cap stone, flashing at the faux stone material, and issues associated with the wood louvers at the gables.

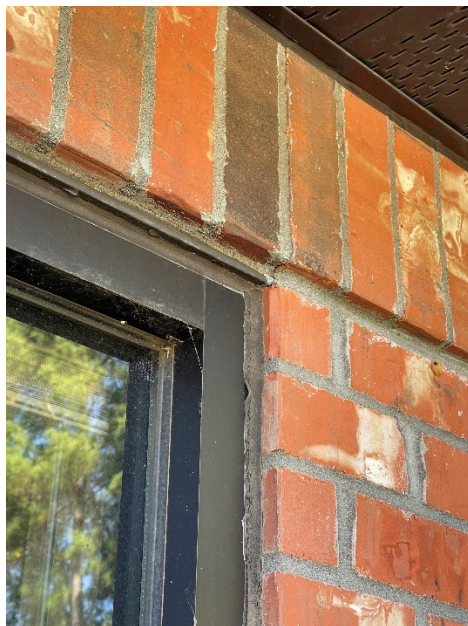
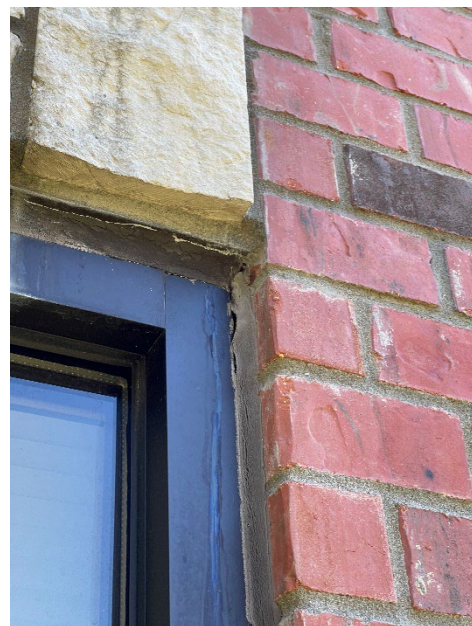
Along this elevation it was noted that the windows do appear to be sized smaller than the masonry rough opening at each location. The amount of sealant used at the head of window openings along this elevation is excessive.

This situation appears to be increased at openings where the faux stone materials is installed above the head of the opening. Due to moisture penetration on the top and through the faux stone, the excess head joints are failing, and the sealant is pulling away from the steel lintel above.

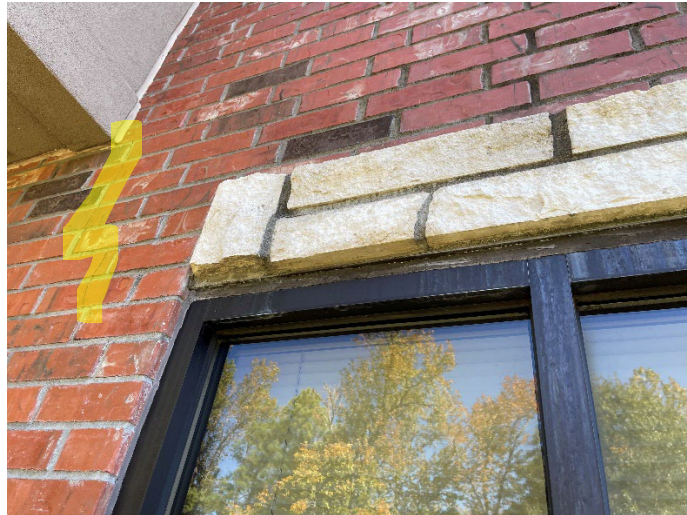
Also noted on this elevation is the development of cracking at masonry joints and through masonry units as well. This cracking has appeared south of wall supported canopy and north of the adjacent window opening. Currently the crack is just to the side of the canopy framing and proceeds down the wall approximately seven masonry courses. The crack is highlighted in yellow in the above image.

It is recommended that the masonry veneer be repaired on the west elevation. The cracking at present is not significant but repairs now will help isolate this situation and track for future issues. Opinion of cost associated with this work is roughly **\$6,500.00**.

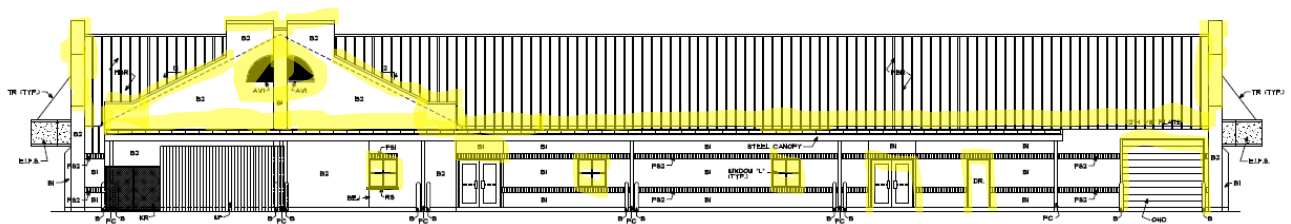
### South Elevation

The review of the South Building Elevation provided similar findings as that of the North and West Elevations. Note the yellow highlighted problem areas observed on this elevation. Summary of problematic areas are: cast stone cap stone at parapet walls, back side of parapet flashing issues, limited to no flashing below the cap stone, degraded sealant around perimeter of window openings, limited flashing at windows (around total perimeter), flashing at solidor course below windows and limited structural support, efflorescence at locations below the cap stone, flashing at the faux stone material, and issues associated with the wood louvers at the gables.

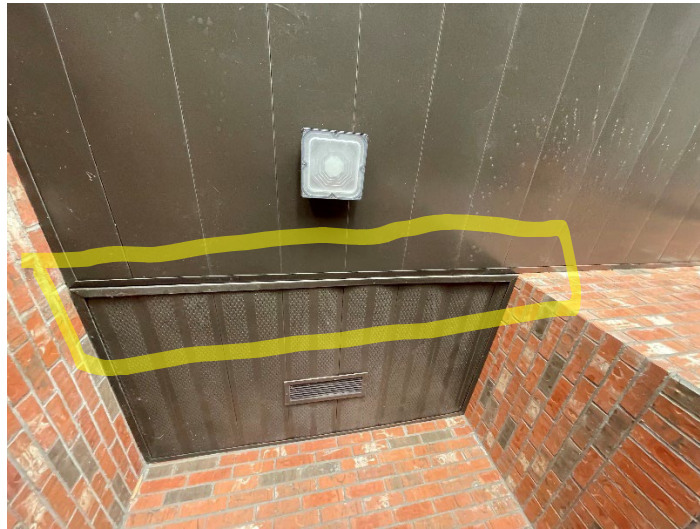
The highlighted area above has presented water intrusion after the winter weather. In addition, this joint line appears to have pushed winter into the interior of the building and this intrusion point will be noted later within the interior portion of this report.

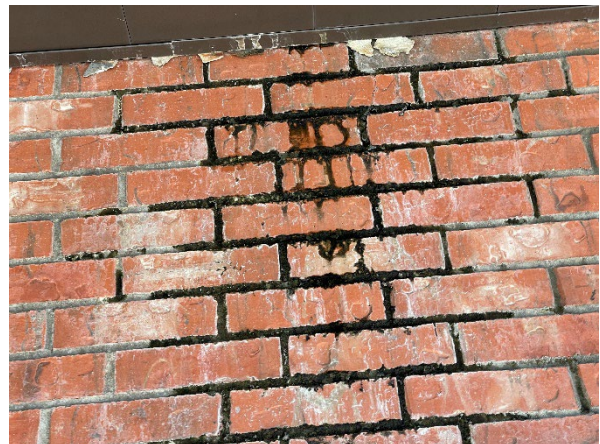
Near the southern east corner of this elevation, there are also signs of water collecting on the surface of the masonry veneer. The water is coming from

above the awning and migrating between the awning panels and the masonry veneer. In addition, mortar was previously placed between this joint and the water intrusion has loosened the material, and it is now falling through joint. This area is appearing directly on the exterior wall of the IT/Data room. No water intrusion was observed on the interior wall at this location.

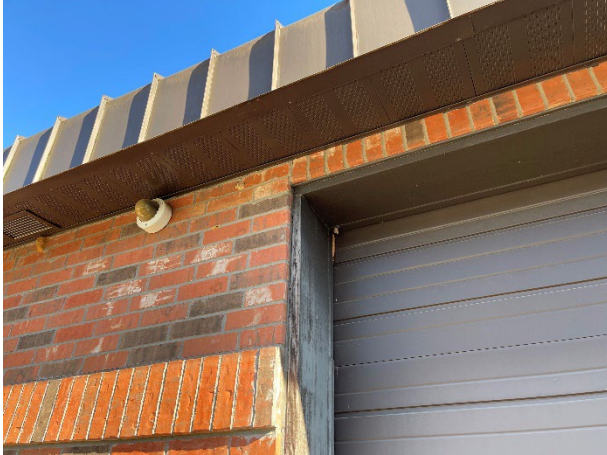
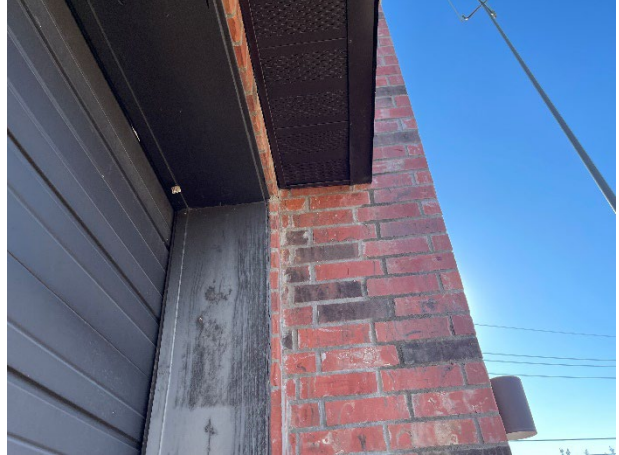
At the overhead door at the evidence entrance area, the rough opening is framed with wood. The wood has been previously painted; however, it is recommended that the wood material be covered with break metal and metal flashing trim.

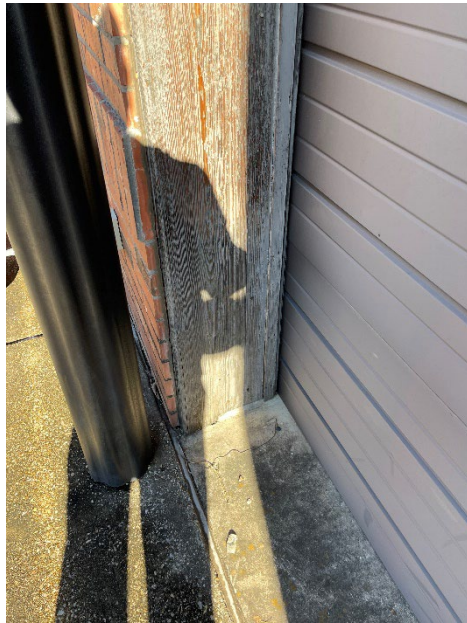
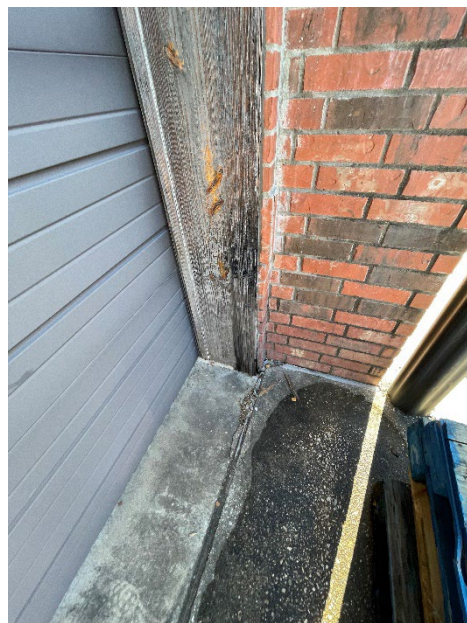
The paint finish has worn from the elements on the surface of the wood. The wood has signs of decay and rot. In the southeast corner of this elevation, roof water runoff ponds on the ground at the bottom of the wood is decaying. Due to the age and damage of the framing, it is recommended to remove and replace the wood and then cover with break metal and metal flashing trim.

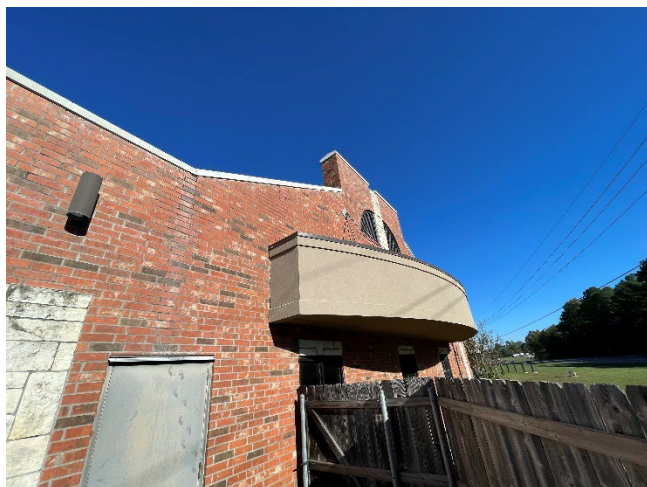
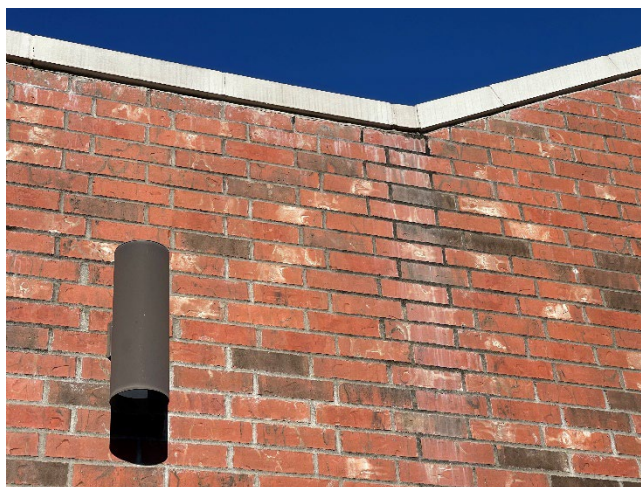
The southeast corner of the east elevation reflects common issues associated with the entire perimeter of the building. Lack of flashing at head of faux stone corbel has led to algae growth on the veneer. Efflorescence is noted at the typical location where the gable feature turns horizontal at the top of the parapet wall.

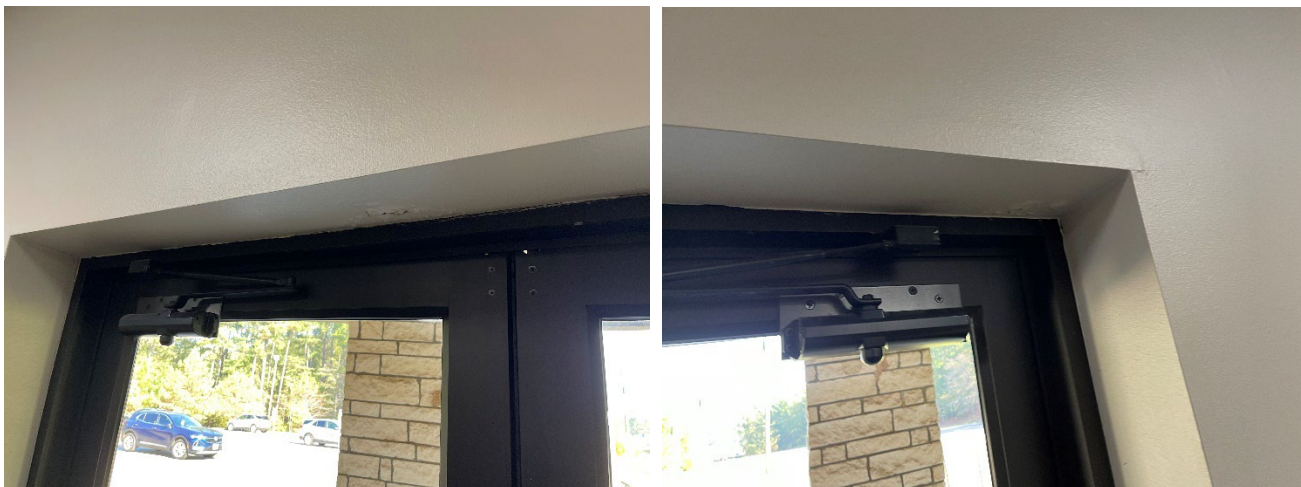
At the gypsum board return at the head of the entrance door, there is obvious signs of water intrusion. Paint has bubbled and pointed to relieve the moisture that is present in the wall cavity at this location. This door is located below the entrance canopy and directly below the double wooden louvers in the gable feature. The “flat” roof of the canopy does provide for the membrane roof to roll up the masonry veneer and then be covered with flashing/counterflashing to stop water. The critical point for review remains the faux stone material directly above the door, as well as, the wooden louvers. The wood louvers should be removed and replaced with new and appropriately flashed. Flashing and sealant should be applied to the faux stone material.

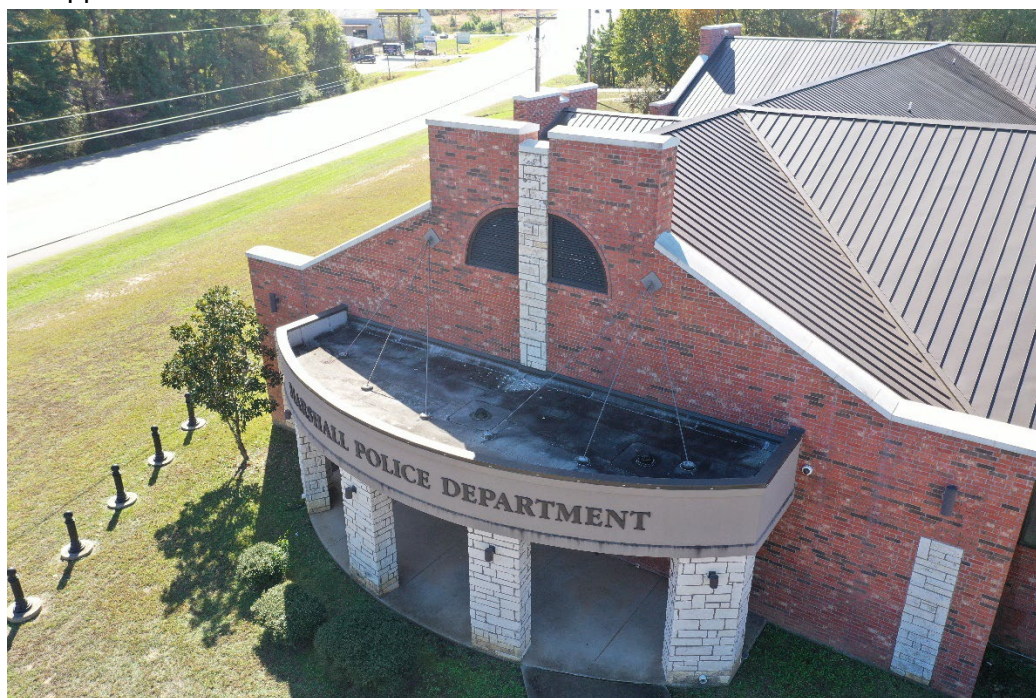
This image is included to reflect the direct relationship of the elements above the entrance door that is located under the canopy.

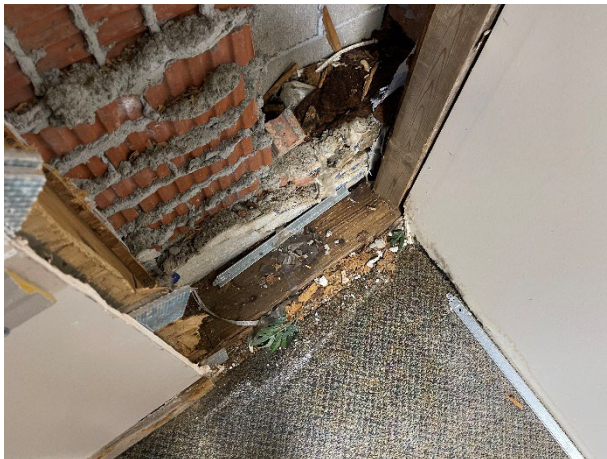
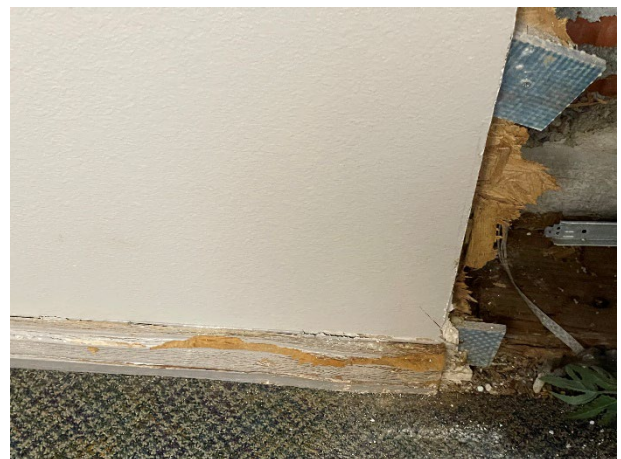
From the roof above water is entering the wall cavity and being absorbed by the wood trusses, wood, framing, gypsum board, wood based, and carpet. The City has previously removed portions of existing gypsum board in an attempt to determine the source of the water. Water has previously been noted and videoed as flowing vertically through this area.

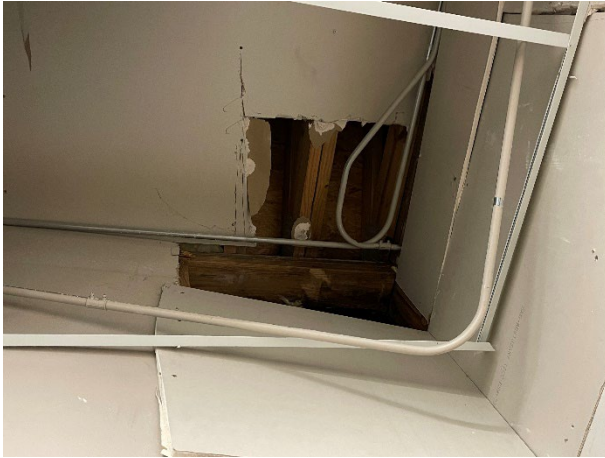
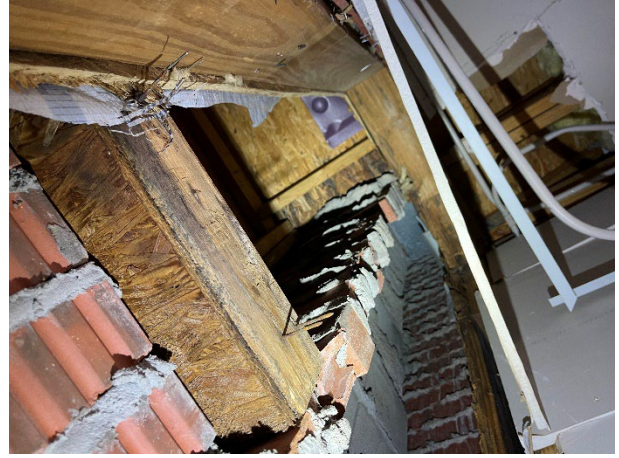
Corner of Lobby prior to removal of gypsum board shown on the left. Image on right reflects current condition in the wall cavity. Area of concern are associated with the wood beginning to decay and rot due to the constant presence of water. Affected areas are the wood top plates, ends of trusses, wood bearing studs, and portions of the OSB wood deck.

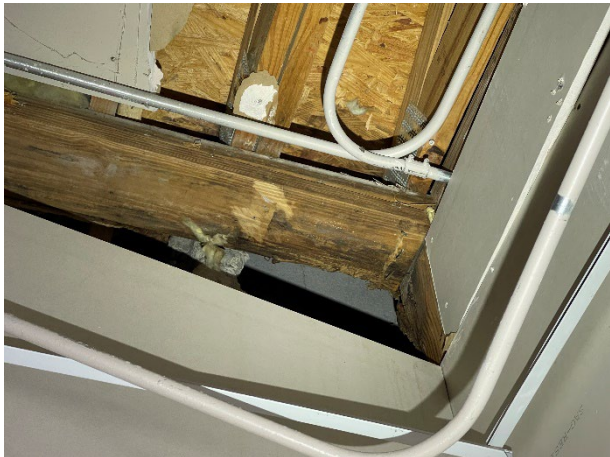
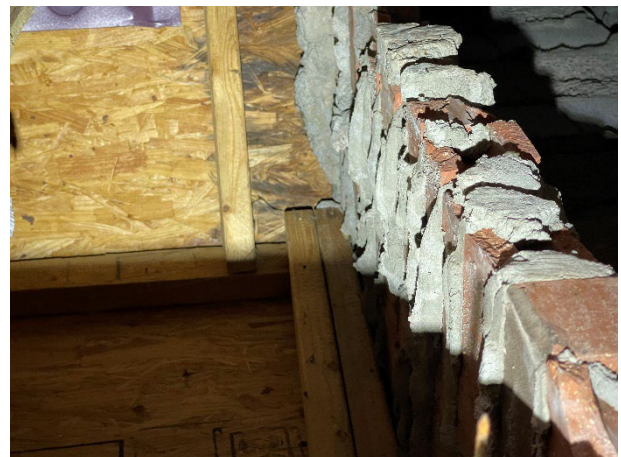
Discoloration of wood framing and OSB is due to water intrusion and the wood absorbing and holding all water from the wall cavity.

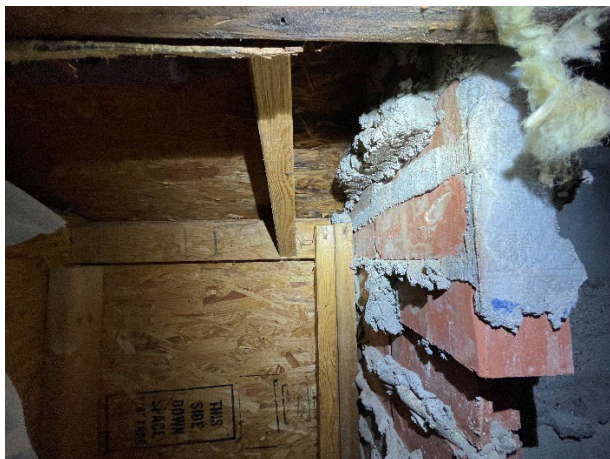
Note wet OSB roof sheathing in left image and damaged framing on the right.

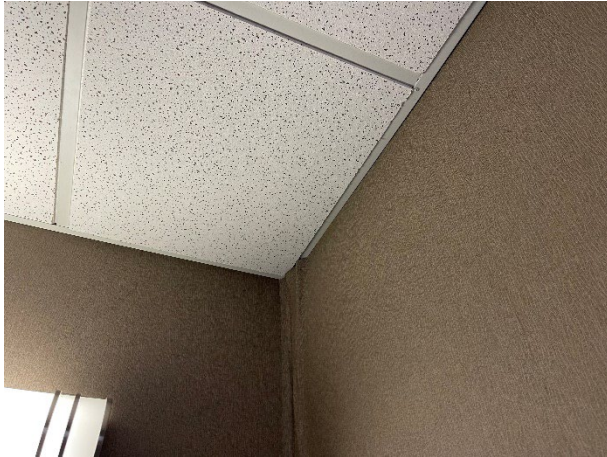
The men's restroom 103 is located on the exact opposite side of the Entrance Lobby. As indicated in the above images, moisture has also penetrated this wall and is causing the wallcovering to separate from the surface of the gypsum board. The corner acoustical ceiling tile was removed and above the ceiling mold was observed on the surface of the gypsum board. Previous moisture was also observed below the wall hung lavatory on the north exterior wall. Portions of VCT indicated glue failure and the rubber base is beginning to pull away from the bottom of the wallcovering/gypsum board.

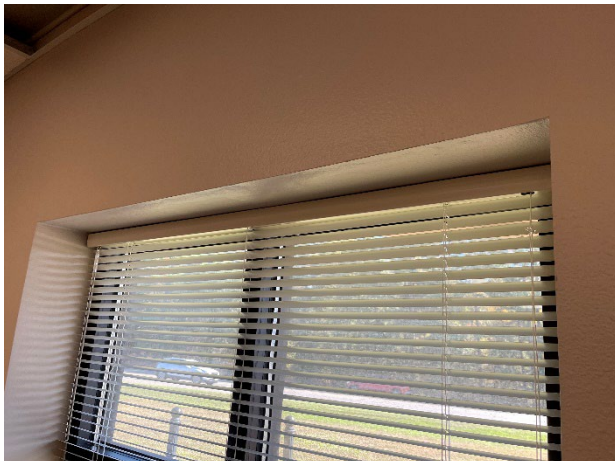
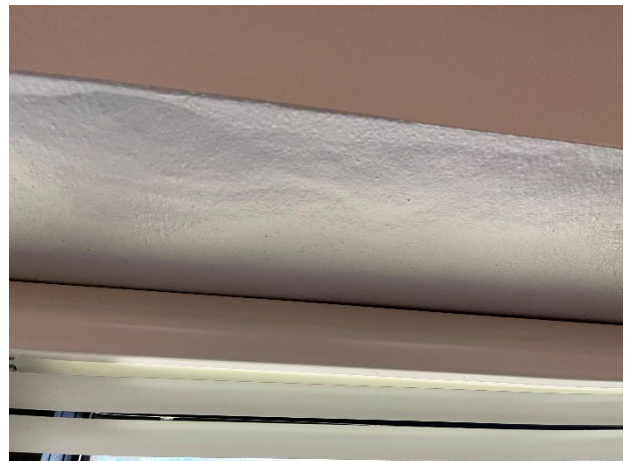
Currently only the head of the window opening appears to be experiencing water intrusion. Water has penetrated the wall cavity and migrating down the wall into the head of the window and resting on the gypsum board return.

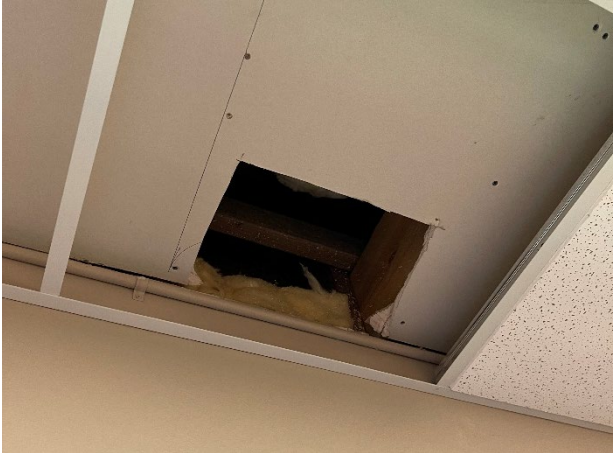
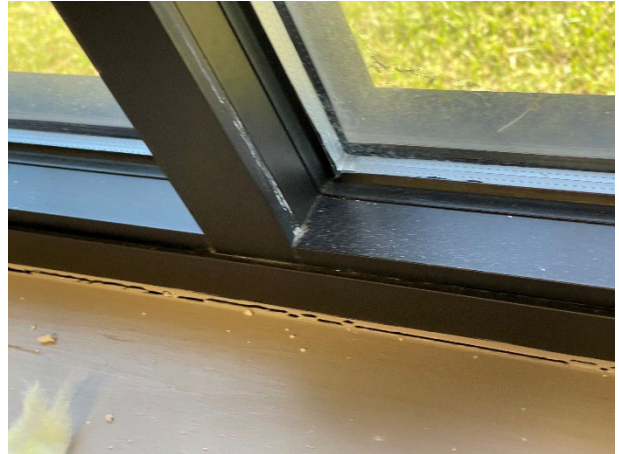
A portion of the gypsum board install on the bottom of the roof trusses was removed to investigate the presence of water above the window. With gypsum board removed no water was observed on or in the exterior wall cavity. However, as noted previously the window units are showing signs of moving due to original installation methods. The window units have minimal bearing on the masonry soldier course and wall framing. The units are gradually moving and separating from the wall framing, as well as, the exterior veneer via separated sealant.

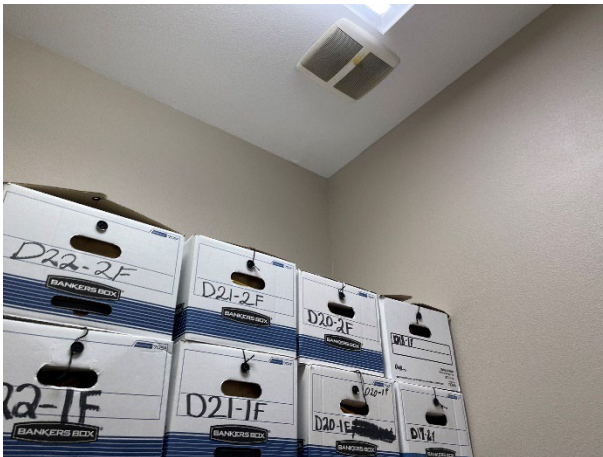
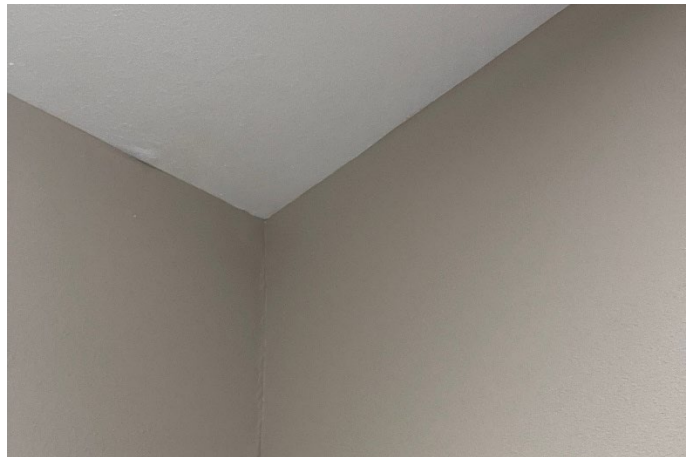
This storage room was another anticipated area of concern due to this corner of the dry storage being located directly at the bottom of the gable feature. On our second site visit bubbling paint was noticed in the upper northeast corner of the room and along the ceiling joint with the north wall. KSA was contacted by the City to return to the site to review new leaks and more pronounced leaks after the winter weather storm. Now in this room significant water intrusion is present down the entire length of this northeast corner. When looking under each shelf, water pocket are visible behind the paint. At the second shelf from the floor, the largest water pocket is completely full and will soon burst.

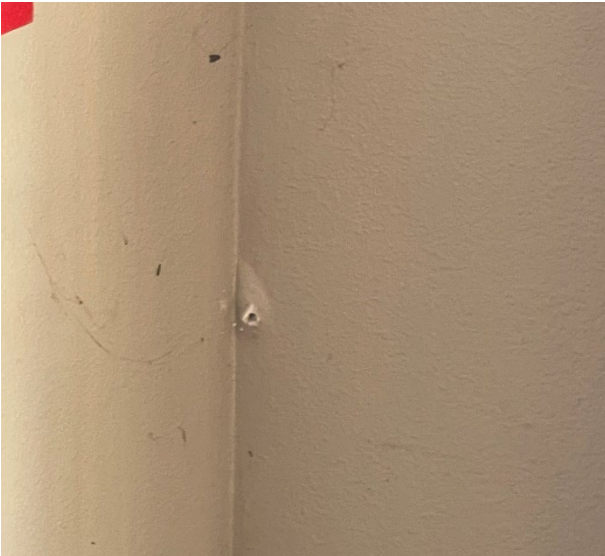
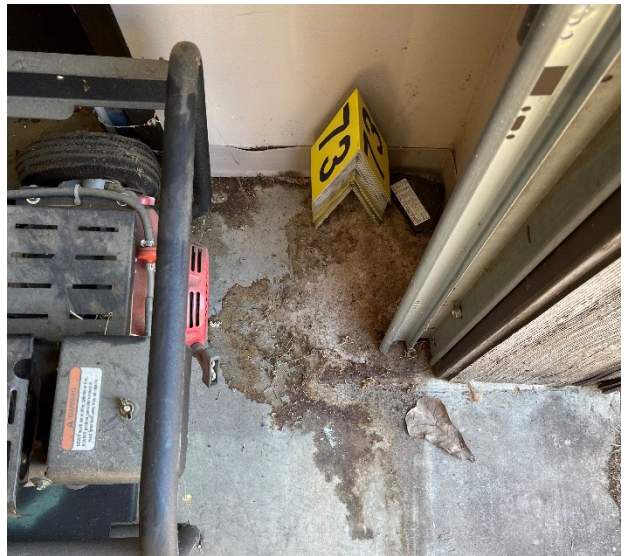
Within the SRT van space there are a few areas that require specific attention. In the southeast corner this area is experiencing the typical water intrusion at the end of the gable at this corner of the building. Similar presence of water is noted via bubbled paint and blistered along this inside corner. In addition, the overhead door is not sealing at the top of slab and water is entering the building under the door and ponding in this corner. This water is being absorbed by the gypsum board and in turn is causing the rubber base to delaminate the glue from the gypsum board surface.

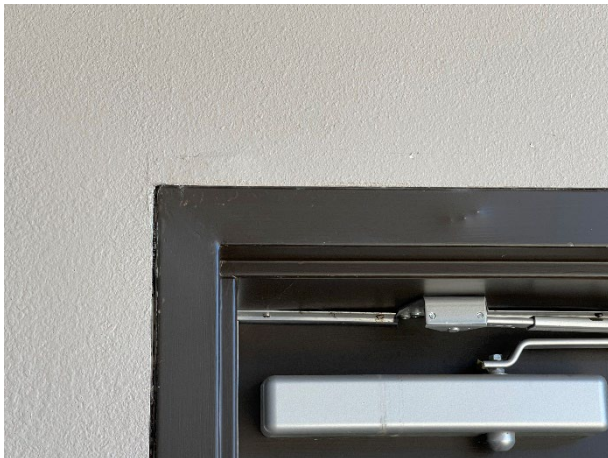
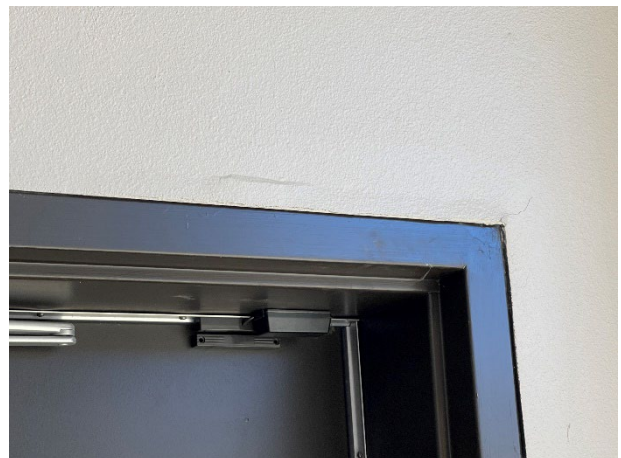
At the exterior man door (P35) with the SRT van area, the hollow metal frame is experiencing movement within the rough opening. The gypsum board tape is beginning to bulge from the surface of the wall. This movement could be due to water from the head of door and/or thermal expansion of the hollow metal frame itself within the masonry opening. No water could be pushed out of the bulges, and on the south end of the door there is a crack forming at a forty-five-degree angle from the door head.

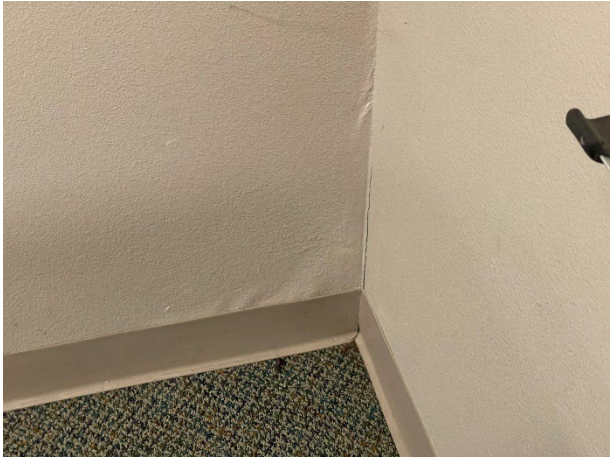
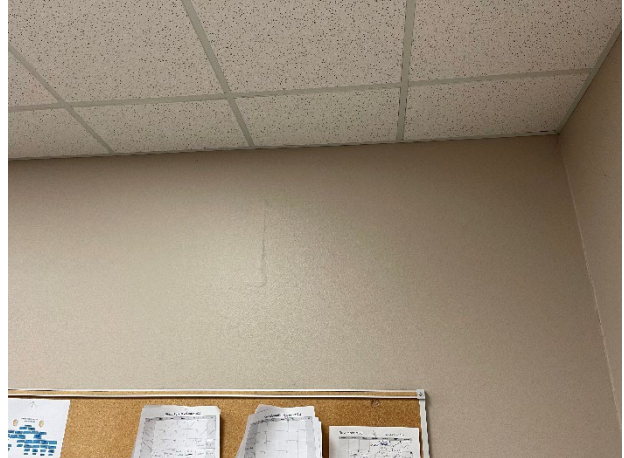
Within the Patrol Briefing this is another room that aligns directly with the end of a gable feature. This corner has signs of water intrusion down the entire southeast corner of the room from ceiling to floor. Water is migrating quickly down the wall and bubbles are apparent in multiple locations. The rubber base is pulling away from the wall and the carpet is absorbing the water as well. In addition, about four feet north of the exterior wall, there is a water pocket just above the tack board.

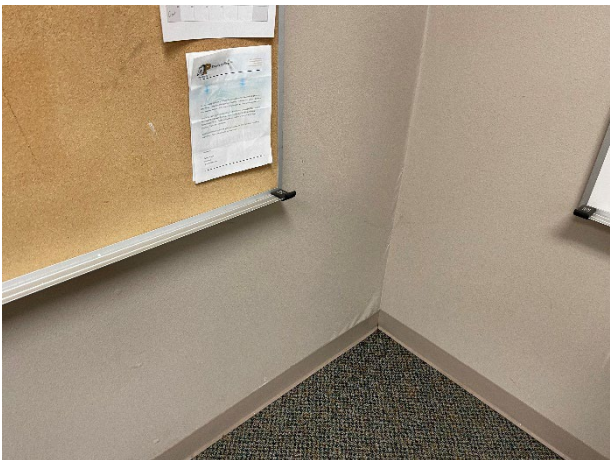
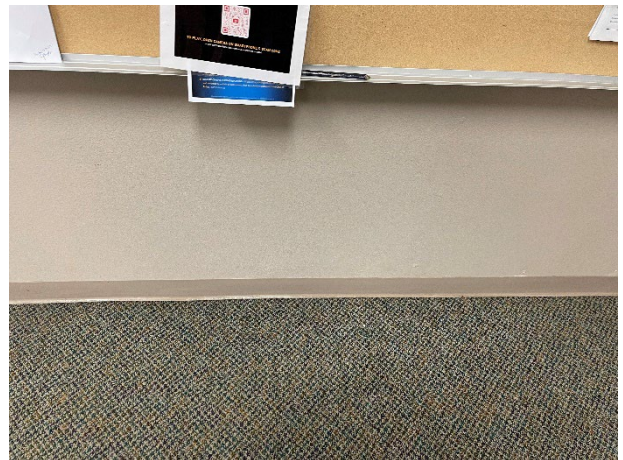
KSA returned to the Police Station to review new and more pronounced leaks after the wintry weather at the end of January. Within the Patrol Briefing room, significantly more water has entered the building, and a large area of the carpet is now completely soaked with water. With the normal water intrusion freezing, it appears that the avenue for the water has been increased in its ability to transmit the water. This area is now proceeding to reach the level of water instruction as at the Lobby.

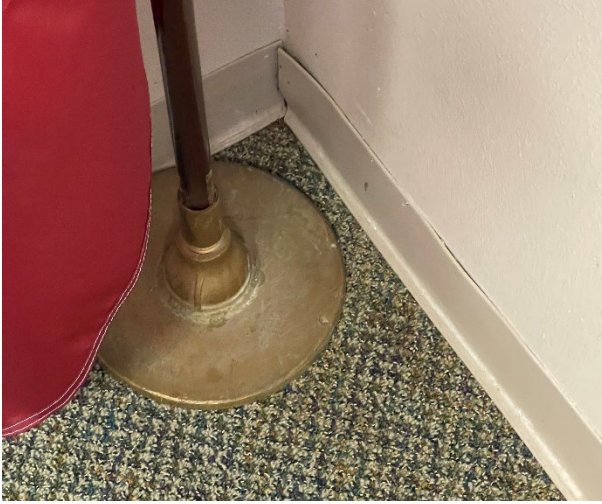
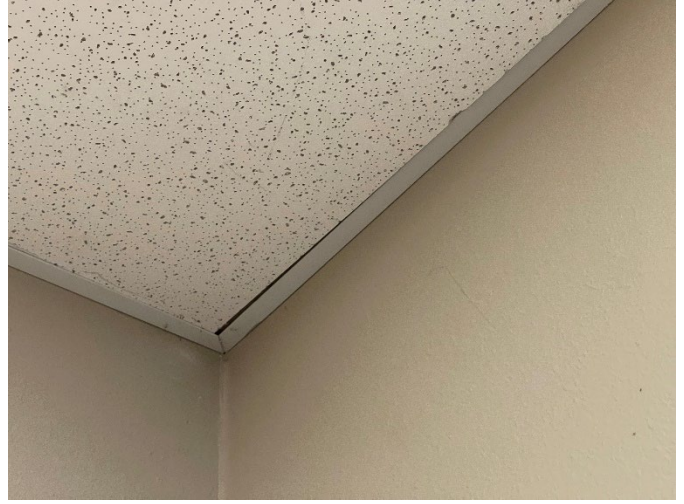
This room has the typical water intrusion issues relative to the location of the gable exterior feature and lack of appropriate roof flashing. This is the southwest corner of the space, and the inside corner of the room has bubbling paint. In addition, the bottom of the gypsum board holds the water and causes the rubber base to delaminate from the adhesive and pull away from the wall. Carpet has signs of previous water intrusion as well.

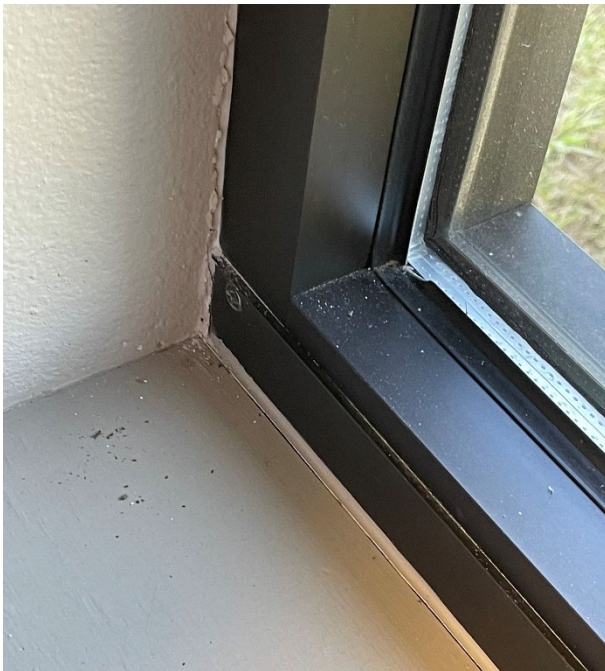
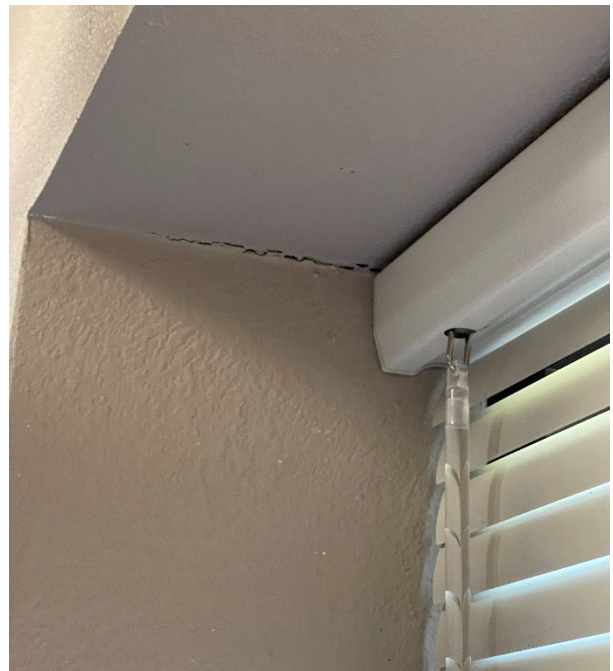
The windows along the west side of the room are experiencing movement in the rough opening of the masonry wall. The wood sills are pulling away from the window sills. The head of the window is cracking between the gypsum board at the jamb and the head. With the limited attachment of fasteners on solid material, the windows are showing signs of movement over time.

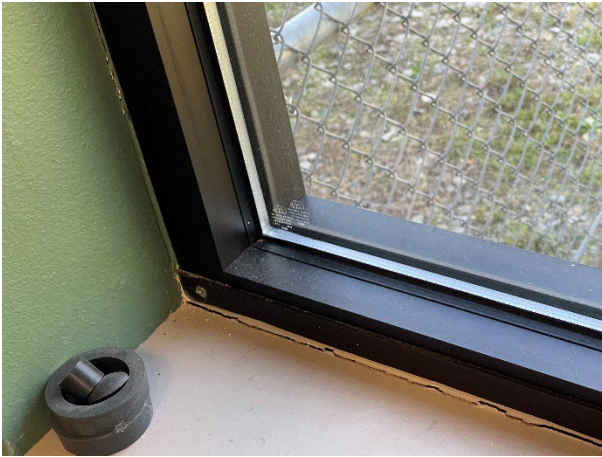
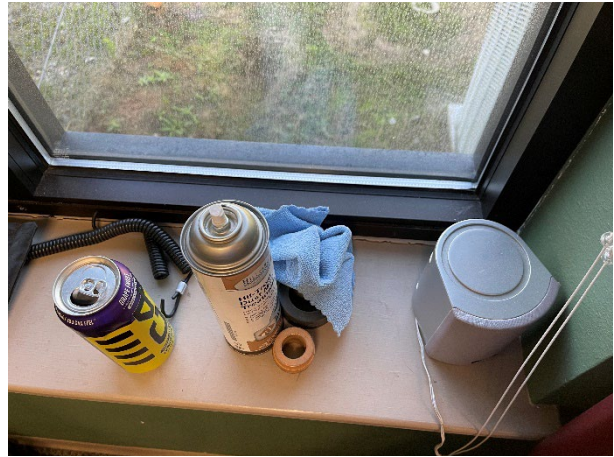
Similar to the Training Room, the windows along the west side of the room are experiencing movement in the rough opening of the masonry wall. The wood sills are pulling away from the window sills. The head of the window is cracking between the gypsum board at the jamb and the head. With the limited attachment of fasteners on solid material, the windows are showing signs of movement over time.

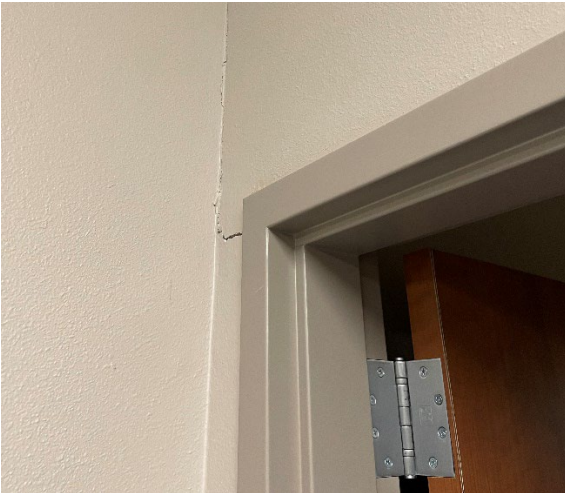
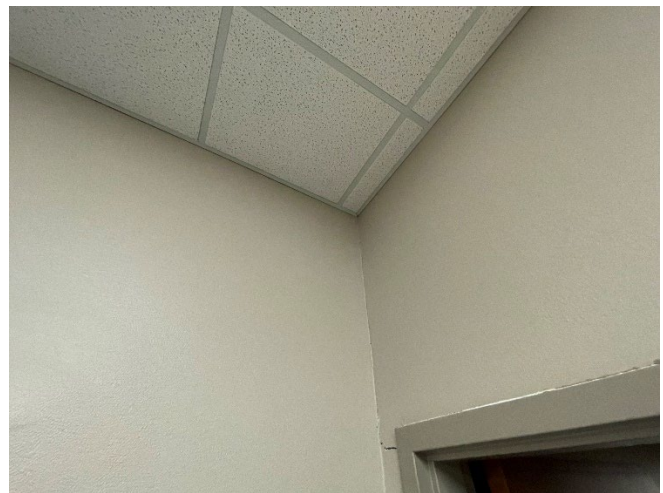
Outside of the Chief and Assistant Chief offices in the administration assistant area, there are additional signs of movement around doors. This door/wall has shifted enough to pull the gypsum board to the point of cracking near the head of the hollow metal frames. The crack has spanned the short horizontal distance of gypsum board and is not running up the inside corner between the sheets of gypsum board.
