TO: City Council  
DATE: May 9, 2024  
ITEM #: 12.B  
SUBJECT: Consider approval of a contract for repairs to the Marshall Police Department building. (Support Services Director)

Investigative Services to Identify Moisture Intrusion Issues at the Marshall Police Station

February 13, 2024

KSA was engaged to provide Investigative Services for the City of Marshall, Texas at the Marshall Police Department. The project is located at 2101 E. End Boulevard North in Marshall, TX 75670. Architects performed this investigation of the existing building to provide an evaluation of existing conditions and recommended corrective measures. This document is structured according to a four-section layout as described below.

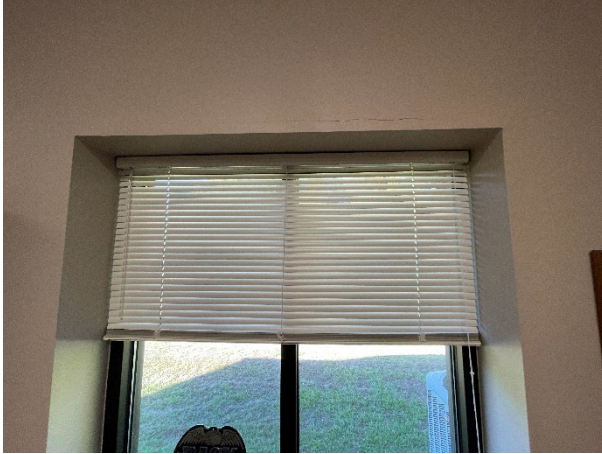
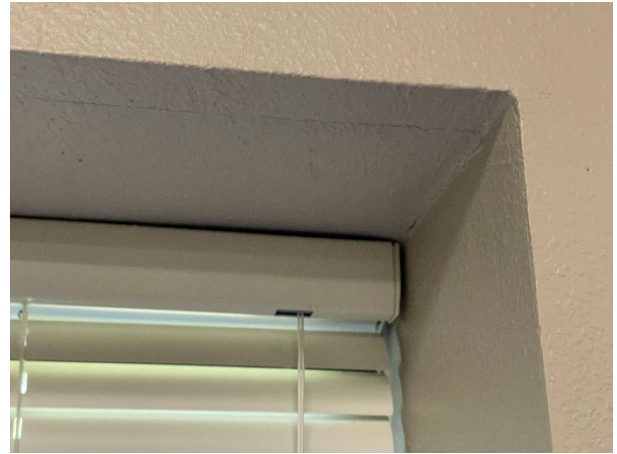
Within the Chief's office window units are also experiencing movement. The head of this window is cracking above the metal corner bead. Within the roof opening, the gypsum board return at the head is also pulling away on the underside of the metal corner bead.

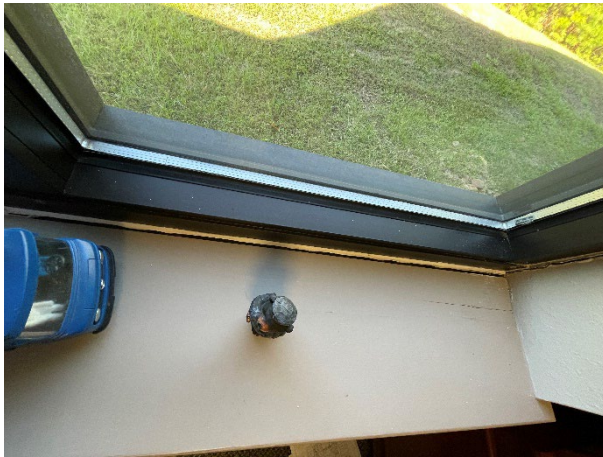
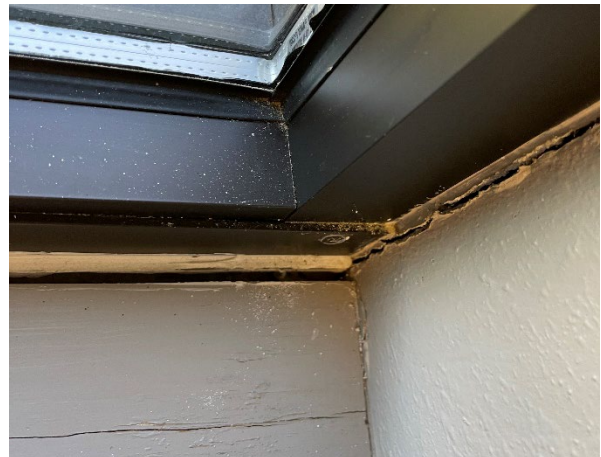
The movement is more pronounced at the lower portions of the jambs and at the sill condition. This is expected given the limited bearing of the window at the masonry veneer and interior wall. The separation of the wood sill to the sill of the window is significant enough that you can see into the wall cavity. The wood sill is even cracking as it moves with the interior wall.

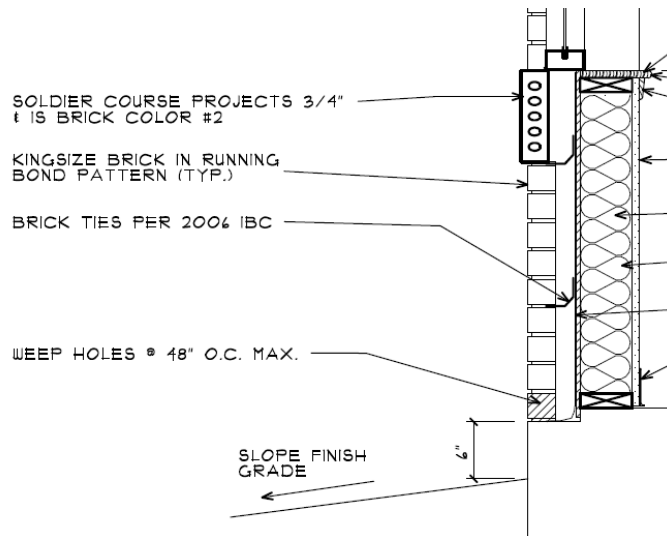
It is unclear how the rough opening was effectively flashed at all locations (head, jamb, and sill). Sill pan installation is not indicated and only masonry ties are labeled in the above wall section. The west side of the building is experiencing the most movement at the windows as indicted by failed interior/exterior sealant and gaps at the jambs and sill. In addition, multiple locations have experienced gypsum board cracking or movement in the metal corner bead. Due to the uncertainty related to the initial construction, we have recommended that all windows be removed, replaced, and all adjacent issues be repaired.
