TO: City Council  
DATE: May 9, 2024  
ITEM #: 12.B  
SUBJECT: Consider approval of a contract for repairs to the Marshall Police Department building. (Support Services Director)

Investigative Services to Identify Moisture Intrusion Issues at the Marshall Police Station

February 13, 2024

KSA was engaged to provide Investigative Services for the City of Marshall, Texas at the Marshall Police Department. The project is located at 2101 E. End Boulevard North in Marshall, TX 75670. Architects performed this investigation of the existing building to provide an evaluation of existing conditions and recommended corrective measures. This document is structured according to a four-section layout as described below.

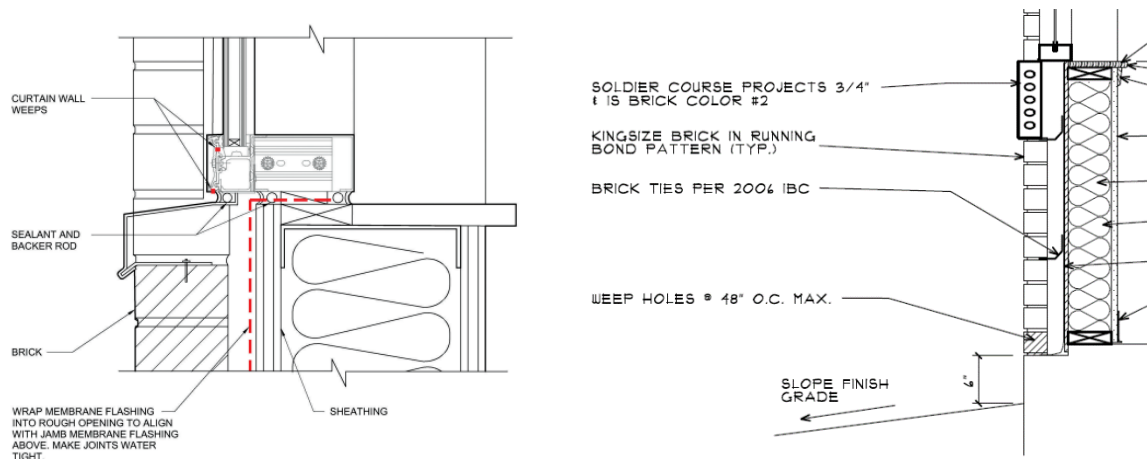
The above detail on the left indicates a proposed new installation with sufficient bearing and attachment for a storefront window unit. The image on the right is the current installation method utilized when the building was originally constructed.

It is recommended that all existing windows be removed and replaced. During this corrective work, all damaged gypsum board, wood sills, and paint finish should be removed and replaced. In conjunction with work, windows to be securely anchored and sized appropriately for masonry rough opening. New flashing to be installed while windows are installed. New windows should be storefront framing system internal weeps utilizing double pane, low e glazing, and insulated units. Opinion of cost associated with this work is roughly **\$125,000.00**.

It is critical to verify that sufficient wood framing/blocking is available to effectively anchor the new windows in place.

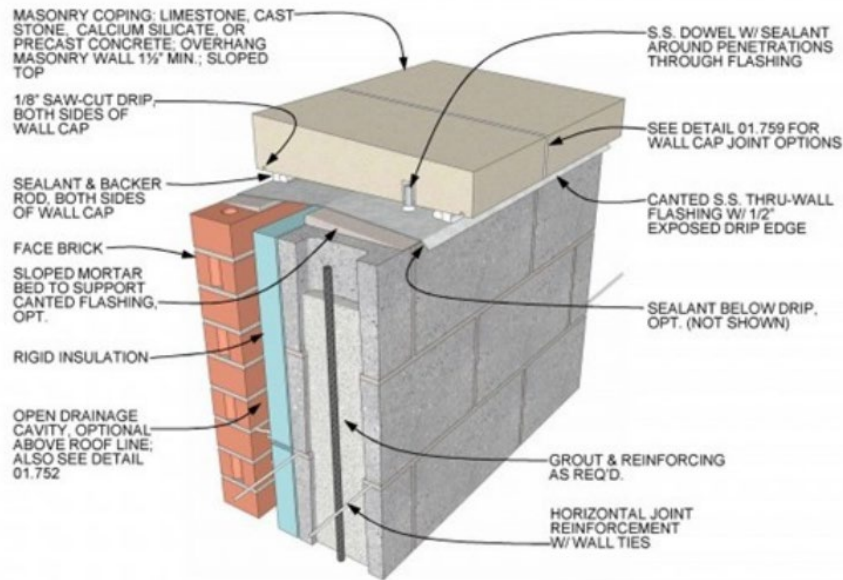
Graphic detail indicated appropriate cast stone with a mono-slope (outside face of building to the interior) and 1/8" drip edges in place on both sides. In addition, note thru-wall flashing below the cast stone cap to prevent water intrusion from above/through the cast stone material.

This detail is typical around the perimeter of the building at each gable element. The limited flashing under the cast stone cap provides opportunity for the porous material to allow water directly into the exterior wall cavity. The limited flashing on the back side of the parapet it not providing a proper seal with secondary protection to keep water from entering at the top of the metal roof panel. The water penetration has been on going and the following photograph indicates the large presence of sealant being used in an attempt to stop the water intrusion. Sealant/caulk should be relied upon as a first line of defense to stop water.

It is recommended that due to the porous nature of the cast stone parapet cap and the insufficient flashing where the metal roof meets the back of the parapet, that these materials be completely covered in prefinished break metal to prevent water intrusion through these materials. The new metal can include metal drip edges as it covered the cast stone cap and then be installed in pieces to appropriately cover and see these elements to effectively stop the water intrusion. This will need to occur around the perimeter of the building at all locations of the gable features, where cast stone parapet caps are installed, and at the intersection of the back of the parapet and the metal roof meets. Opinion of cost associated with this work is roughly **\$75,000.00**.

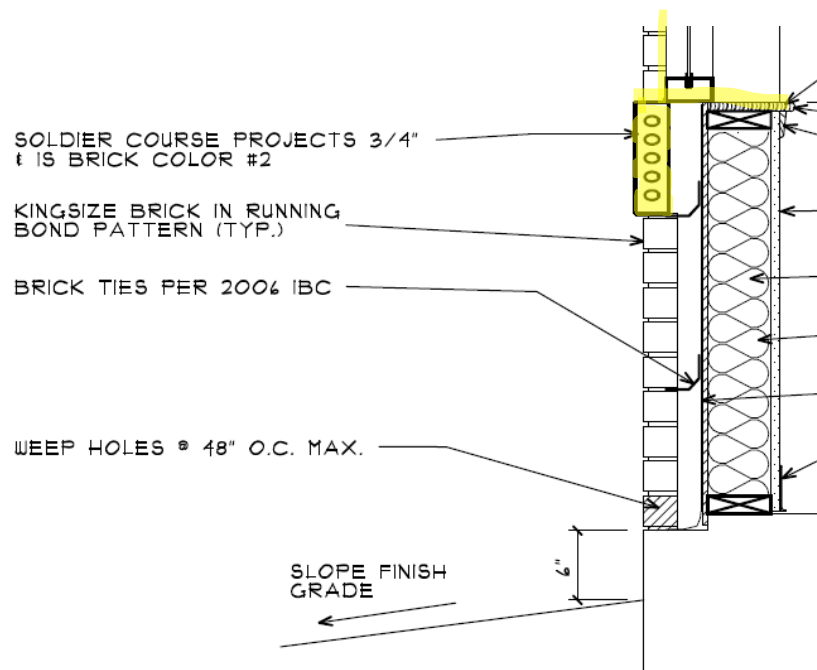
Varying gap thicknesses are noted around all windows from the window movement and sealant failure. Masonry movement and cracking is noted as well. The sill is a king size masonry unit installed as a soldier course. The soldier units are cantilevered vertically with little or no support, and they have begun to move through thermal expansion.

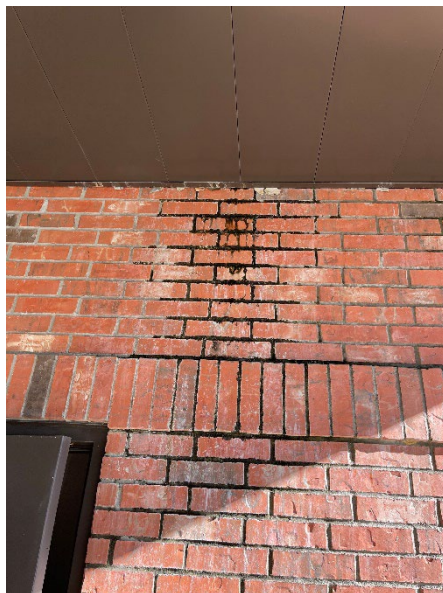
The highlighted area above has presented water intrusion after the winter weather. In addition, this joint line appears to have pushed winter into the interior of the building and this intrusion point will be noted later within the interior portion of this report.

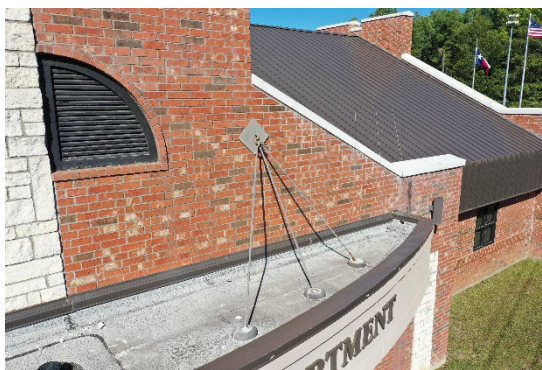
East elevation wall supported canopy is provided with one internal drain and a very small overflow scupper.

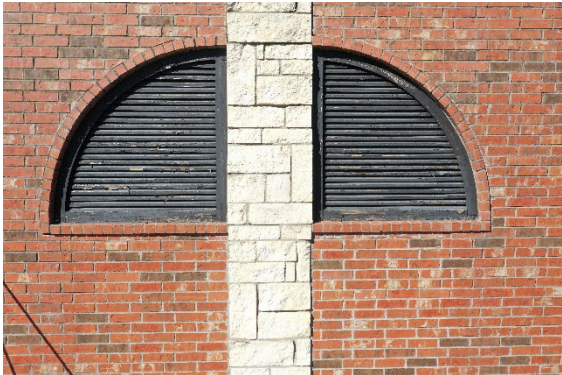
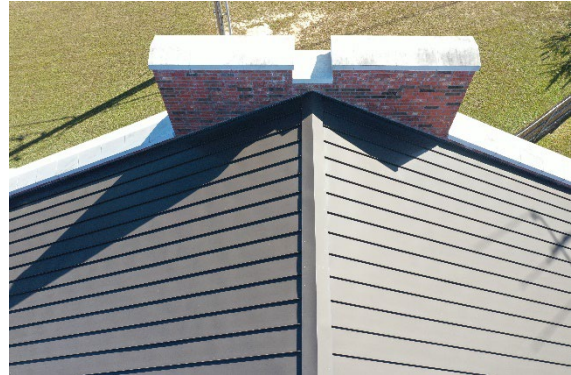
A drone view of the gable louvers reveals aging and deterioration of the paint and overall assembly of the wood louver units. No perimeter flashing is apparent along either vent. A back side of the top of the gable feature highlights the limited use of flashing height and length to properly protect the edge roof panel from water intrusion. This is particularly apparent at the limited extension of the parapet above the roof panel on the slope edge.

The existing wooden louvers are not flashed appropriately, and the wood finish and overall condition of the louvers are deteriorating. It is recommended to help limit water intrusion through the louvers that they be removed and replaced and for new flashing to be installed during installation. Opinion of cost associated with this work is roughly **\$12,500.00**.

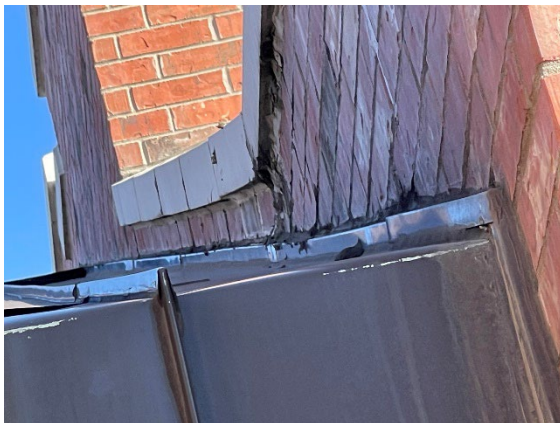
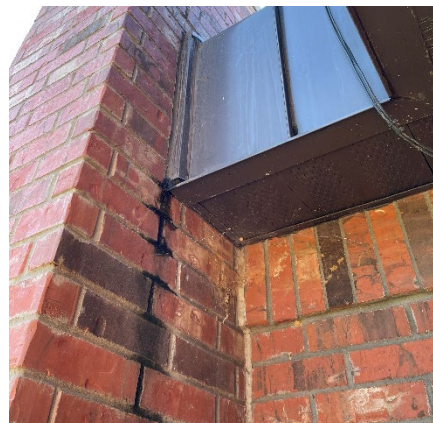
Backside of gable parapet with signs of extensive sealant being utilized as first line of defense to stop water intrusion. Gable feature extension is showing signs of moisture discharge from roof turn down with extensive algae growth. At this point not only is water entering the wall cavity but its presence on the exterior wall is significant enough to provide an avenue for algae growth the masonry mortar joint lines (both horizontal and vertical).

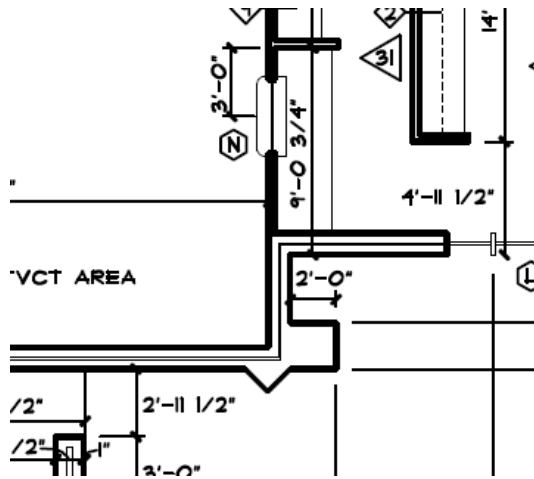
Northwest corner of Lobby 101

The northwest area of Lobby 101 is the most impacted area of the interior of the building for water intrusion. This condition along the back side of the gable with the limited flashing and an adjacent valley has contributed to significant water intrusion and damage in this area.

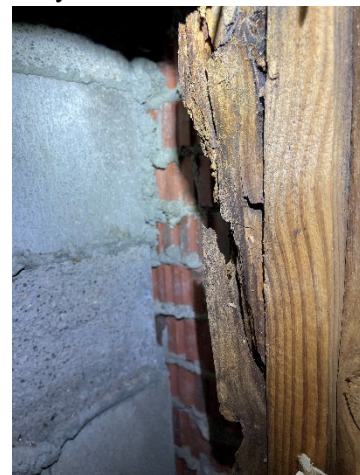
Note wet OSB roof sheathing in left image and damaged framing on the right.

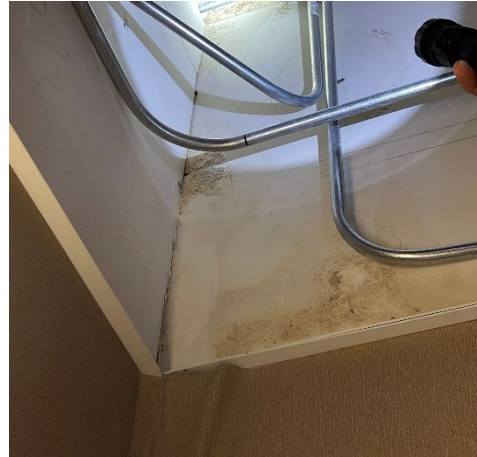
### Men's Restroom 103

The men's restroom 103 is located on the exact opposite side of the Entrance Lobby. As indicated in the above images, moisture has also penetrated this wall and is causing the wallcovering to separate from the surface of the gypsum board. The corner acoustical ceiling tile was removed and above the ceiling mold was observed on the surface of the gypsum board. Previous moisture was also observed below the wall hung lavatory on the north exterior wall. Portions of VCT indicated glue failure and the rubber base is beginning to pull away from the bottom of the wallcovering/gypsum board.

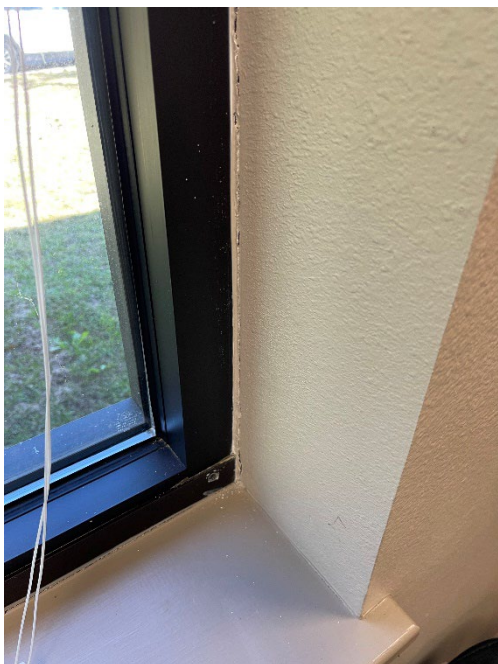
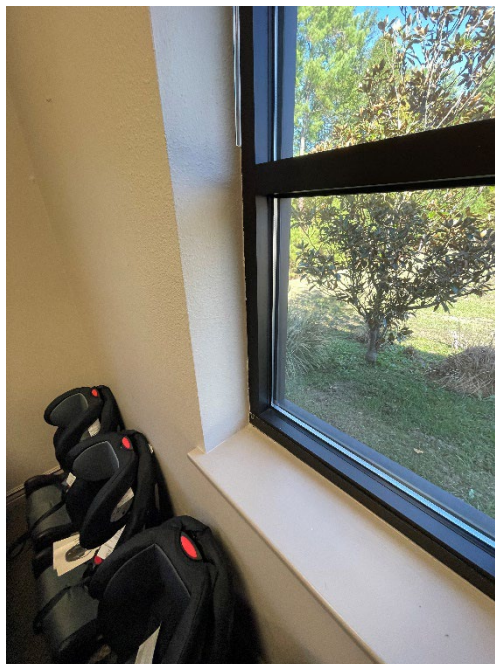
Assistant Chief 181

This office is in the northwest corner of the building and is experiencing the most movement associated with the window units located in the exterior masonry wall (specifically on the west wall).

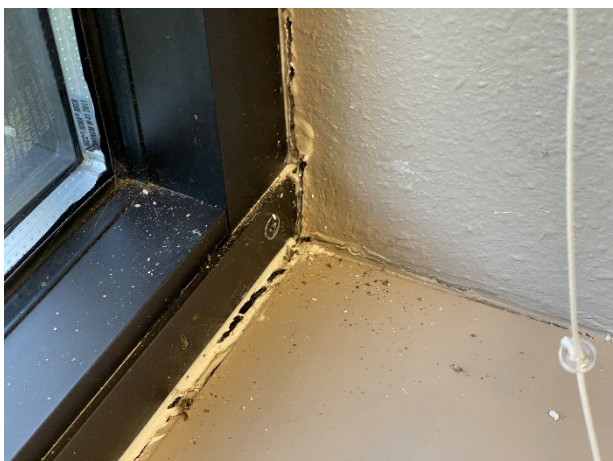
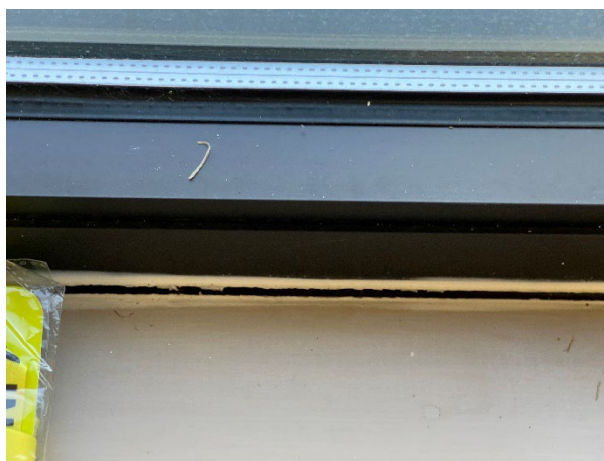
Windows along the north elevation have some movement. Most obvious locations are along the lower portions of the jamb and at the sill.

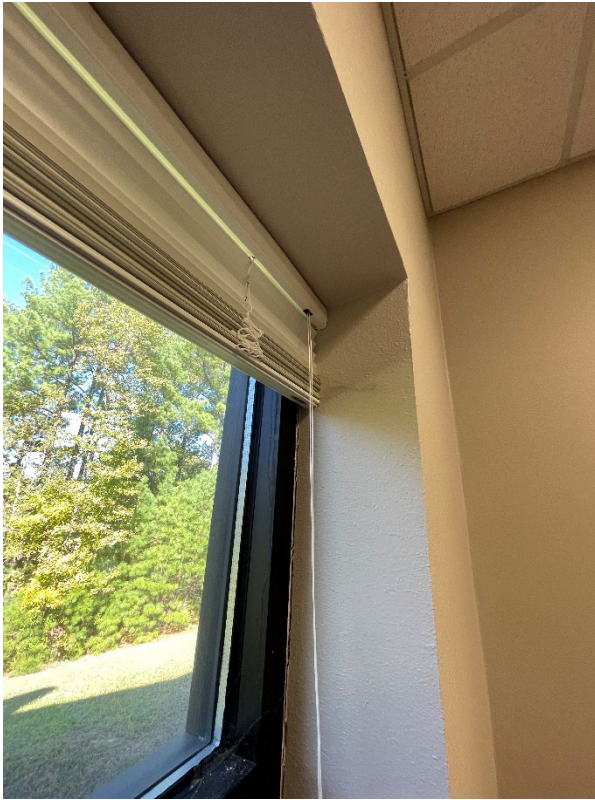
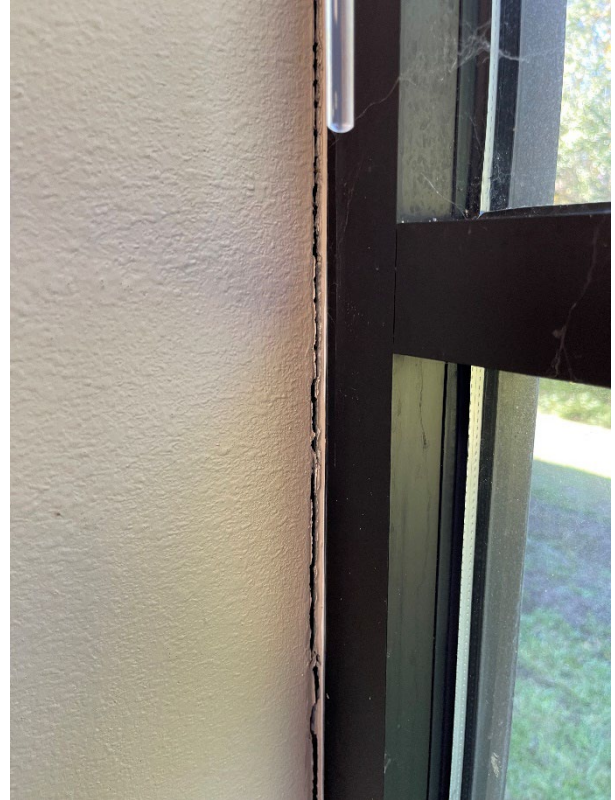
West elevation windows have significant movement around the jambs and sill of the rough opening. Again, movement at sill is large enough to provide visual sight line directly into the wall cavity.

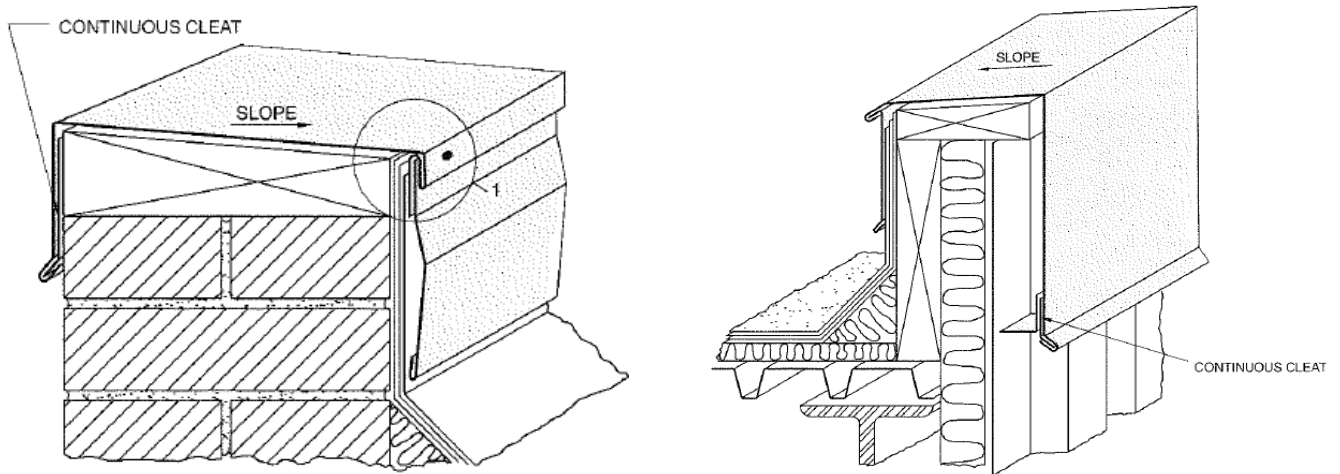
Not that the coping is a continuous piece that wraps all portions of the parapet. A continuous clear is provided on the exterior side for attachment of the break metal and to form a drip edge. The coping material is sloped internal to the roof and attached again on the back side. This condition typically interacts with the additional flashing and/or the proposed roof system being extended up the parapet and under the coping material.

Although this type of detail was incorporated into the original design for the Police Station, it is proposed to retroactively install a similar situation over the existing conditions.

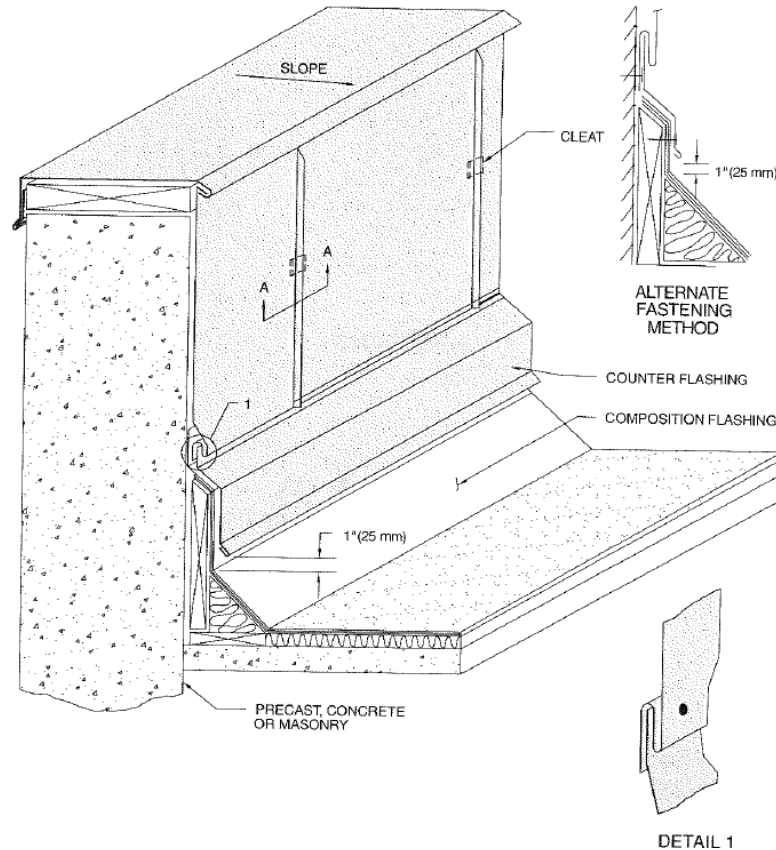
Redundant flashing is critical to the longevity or properly protected details at roofs and wall penetrations. The above detail indicates necessary counter flashing to cover the first layer of base flashing.

The detail to the right provides an enlarged view of the appropriate use of a reglet and counter flashing to ensure that the joint in question is protected by multiple layers of intentional defense.

It is recommended to completely cover all portions of the cast stone cap and run metal down the backside of the masonry parapet and provide a new flashing detail at the intersection of the parapet to the roof material. As a general concept, this is a similar detail to address the water intrusion at the parapet wall locations:

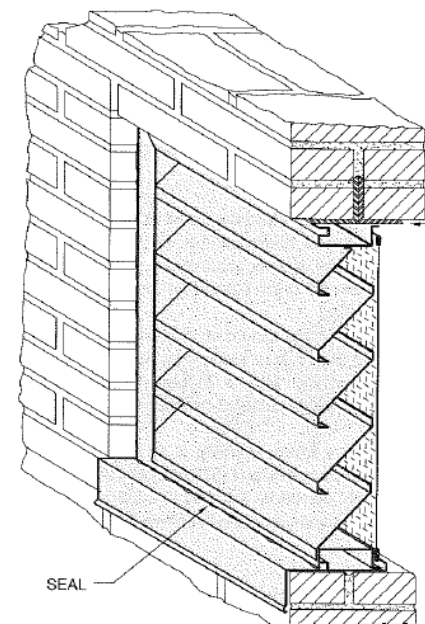
Another issue to address is the gable wall louvers. The existing material is wood and the finish is beginning to fail, and they do not effectively block moisture penetration. New formed values have varying blade angles that prevent the passage of moisture. In addition, when the existing louvers are new perimeter flashing can be installed – especially sill flashing as indicated to the right.
